# GAVÀ UNIÓ DE COOPERADORS REHABILITATION

J.L SERT - J. TORRES CLAVÉ  
(1936)

MERITXELL INARAJA I GENÍS, arquitecta

Category A - 06A001245 - March 2023

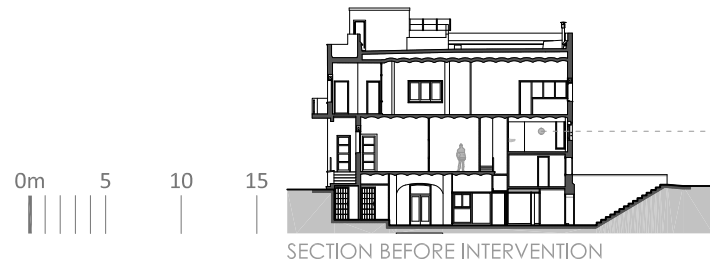
SECTION BEFORE INTERVENTION

Many of the architectural elements were preserved embedded in the later interventions
