GAVÀ UNIÓ DE COOPERADORS REHABILITATION

J. L. SERT - J. TORRES CLAVÉ
(1936)

MERITXELL INARAJA I GENÍS, arquitecta

Category A - 06A001245 - March 2023

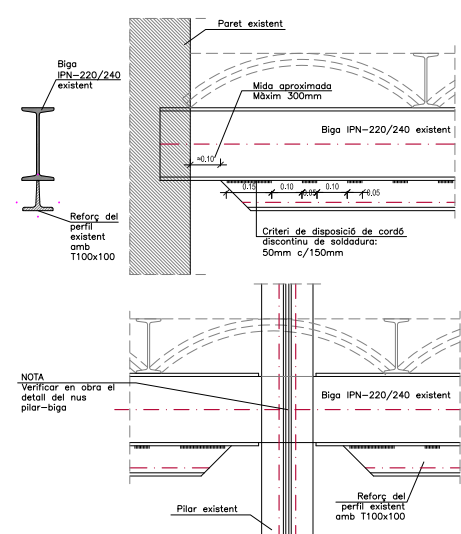
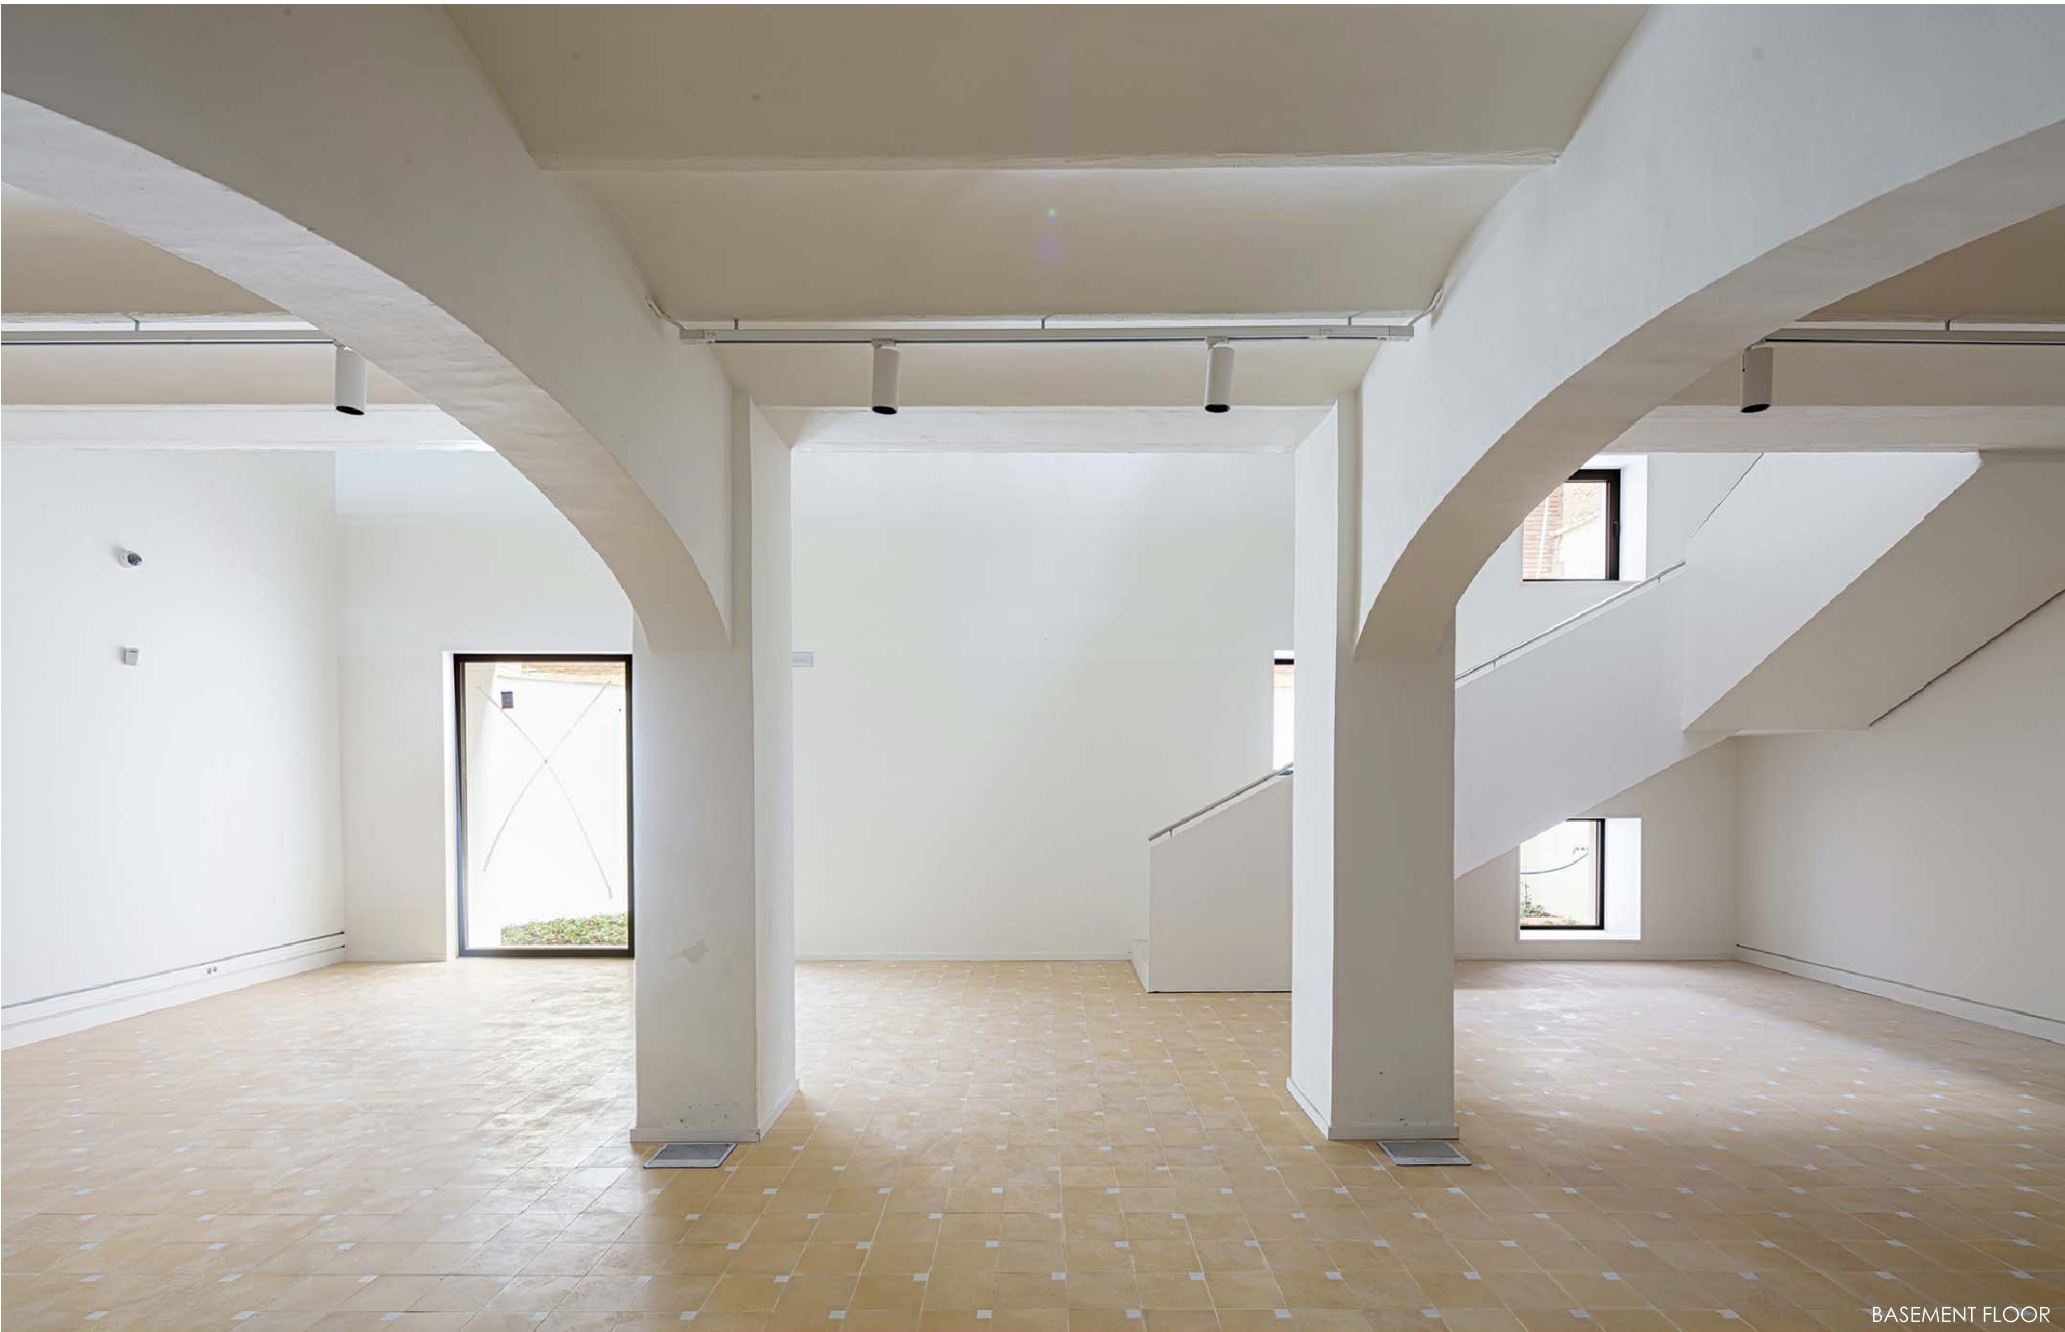
STRUCTURAL DETAILS (REINFORCEMENT)

REFORÇ DELS PILARS

REFORÇ DE LES BIGUES

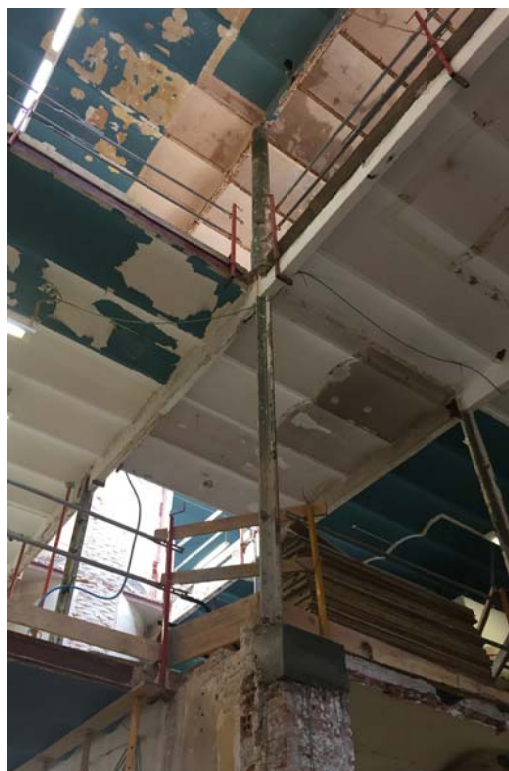
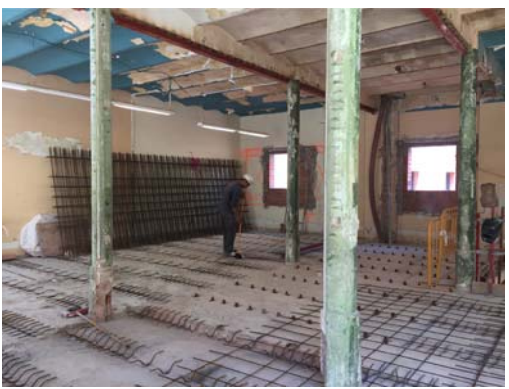
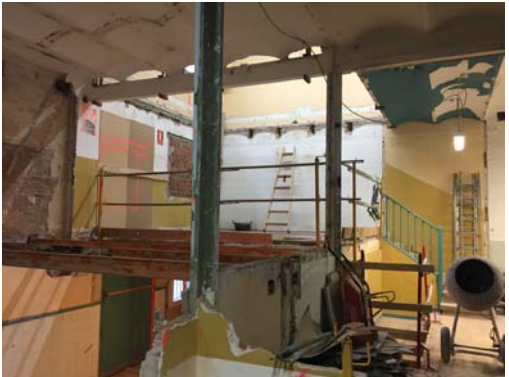
BASEMENT FLOOR

Once all the values of the building have been recovered, taking advantage of the fact that the rear bay originally intended for service spaces had been very altered -new slabs and divisions-, this part is emptied to create a double space and a new scale that allows the visual and functional relationship of all the floors of the building and the performance of the fire and evacuation regulations of compulsory compliance. This intervention allows to give light to the basement and provide it with new activity and open it to the rear courtyard.
