Restoration of Casa Batlló

Authors: Xavier Villanueva · Ignasi Villanueva · Mireia Bosch · Ana Atance

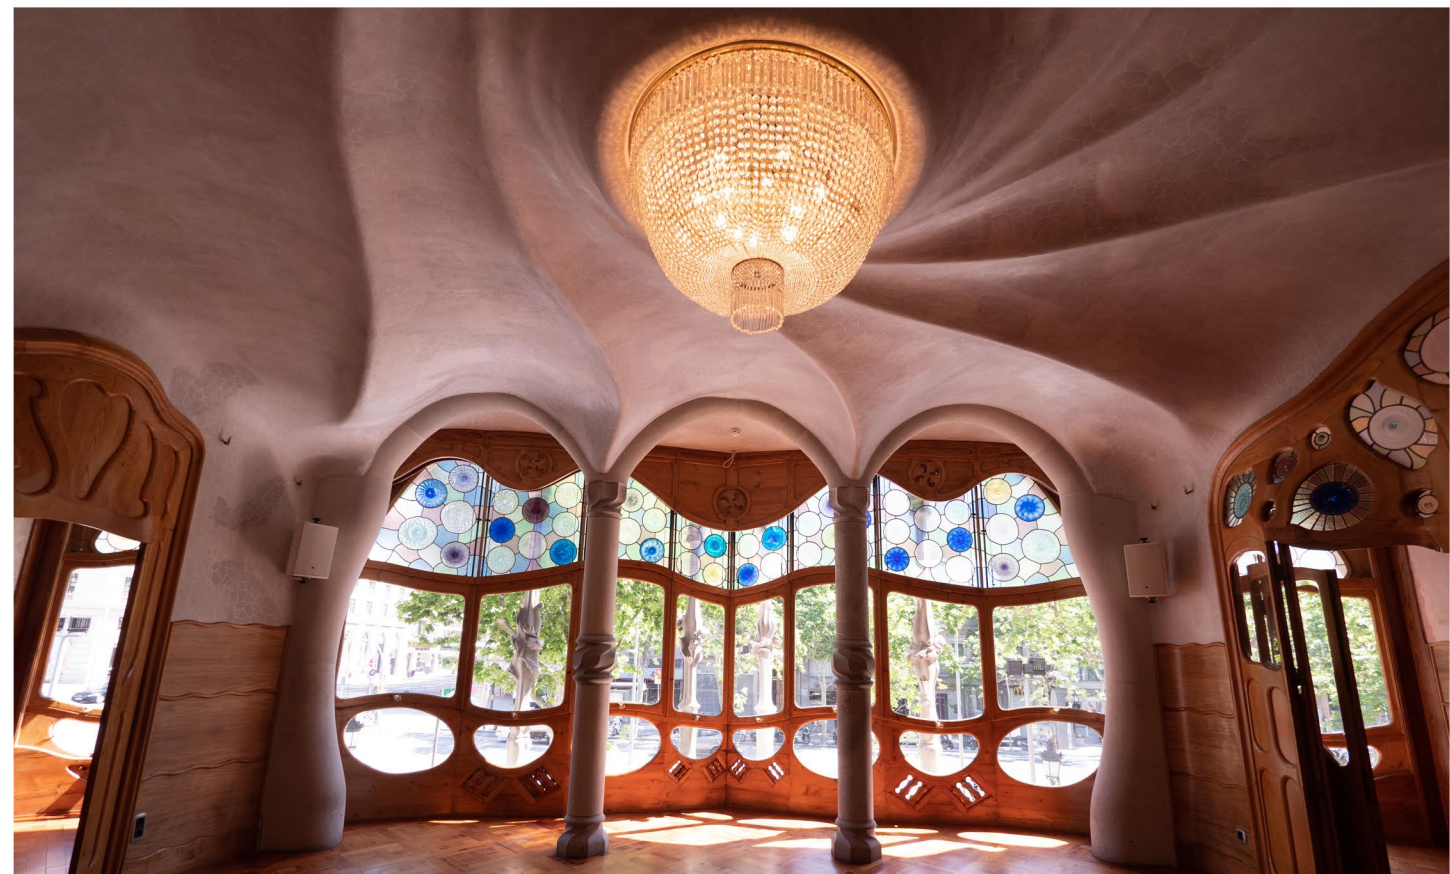
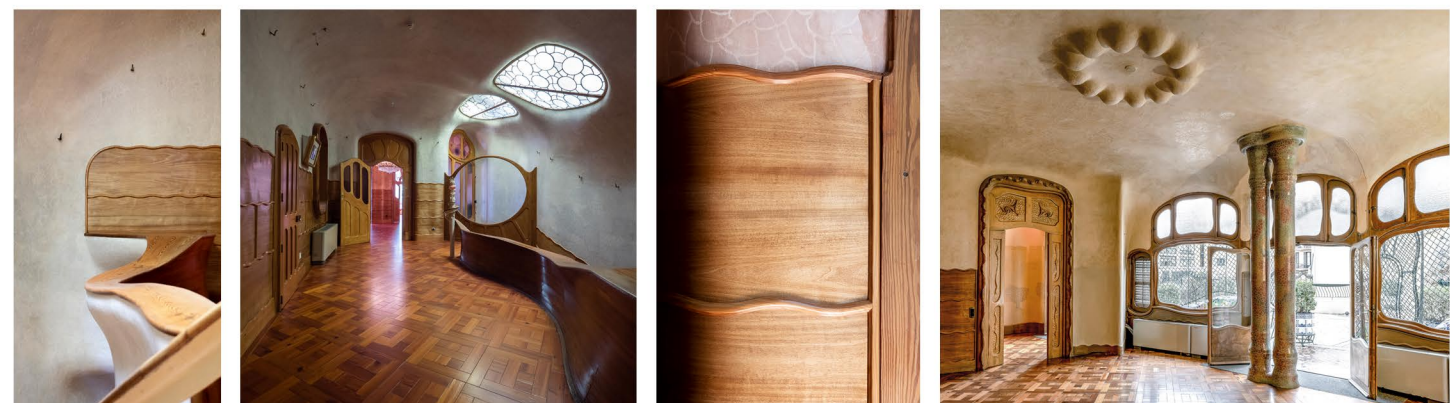
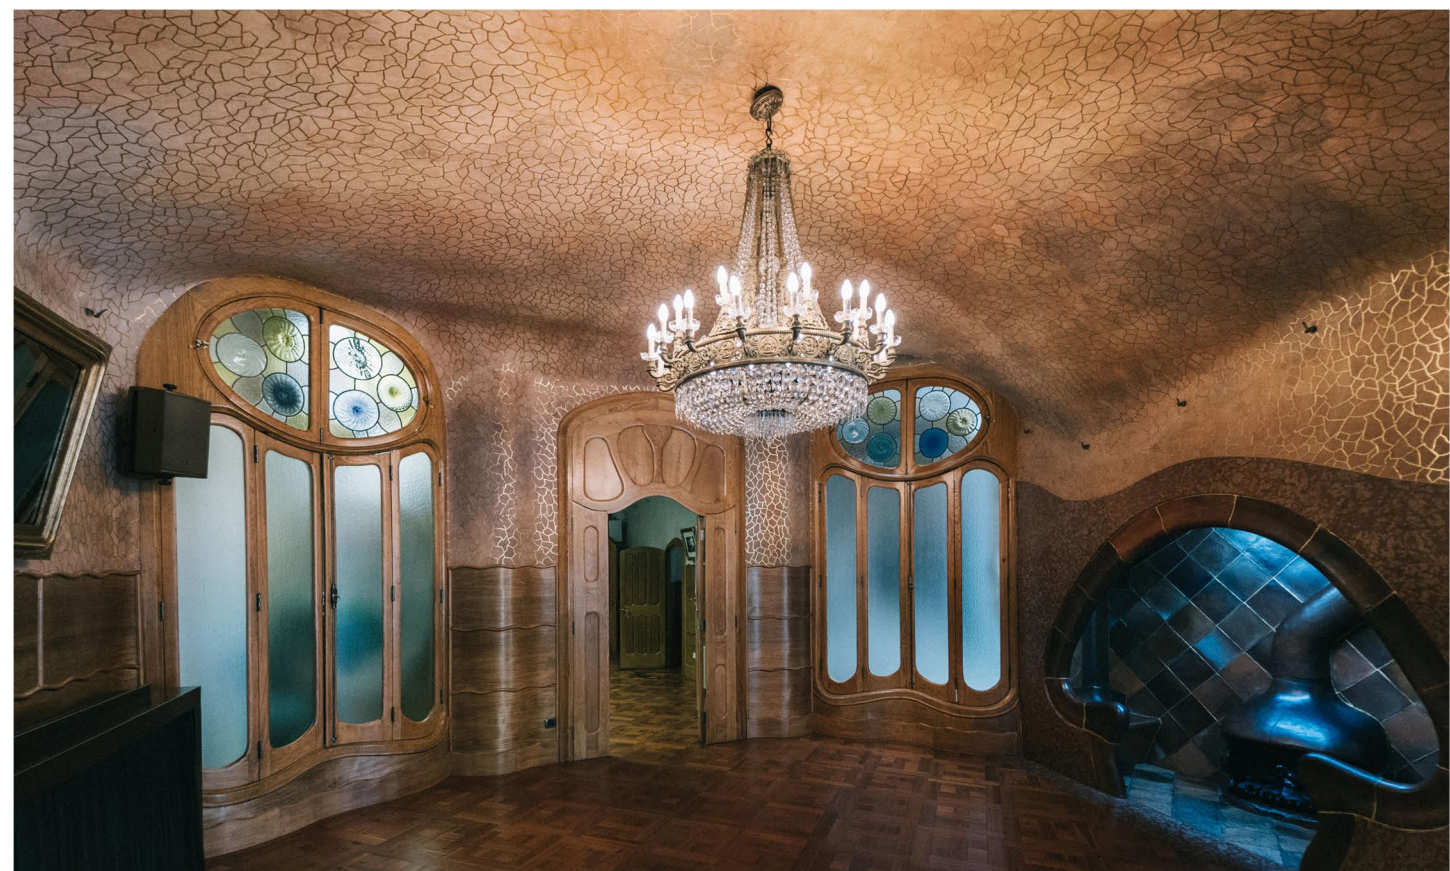
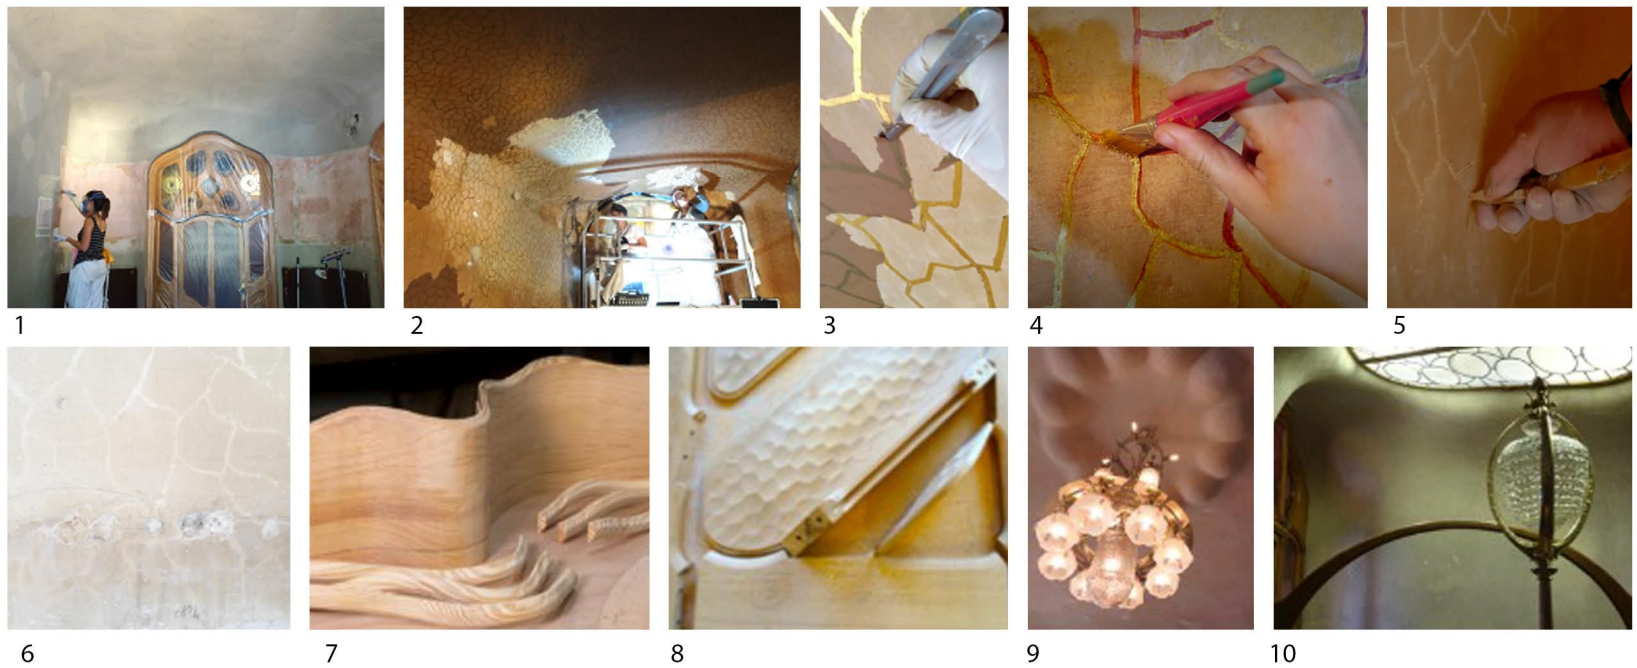
For the fabrication of the reproduction of this wainscot, the geometric templates were put together for of each of the rooms (7). Thus, in the reproduction of the pieces that form the frame of the wainscoting, a criterion of discernibility was defined between the wainscoting reproduced in original walls with respect to those that were not: in the rooms where the distribution was original, the vertical slats are arranged in the short vertical between the undulations, while than in the non-original rooms, in the long vertical.

It was also necessary to reproduce the lamps in the dining room (9) and the noble staircase(10) as well as the large oval door that finished off this same staircase (10). Point clouds were obtained from the deposits of the National Museum of Catalonia (MNAC) to reproduce three doors and a large closet in the hallway of the private area of the noble floor (8).
