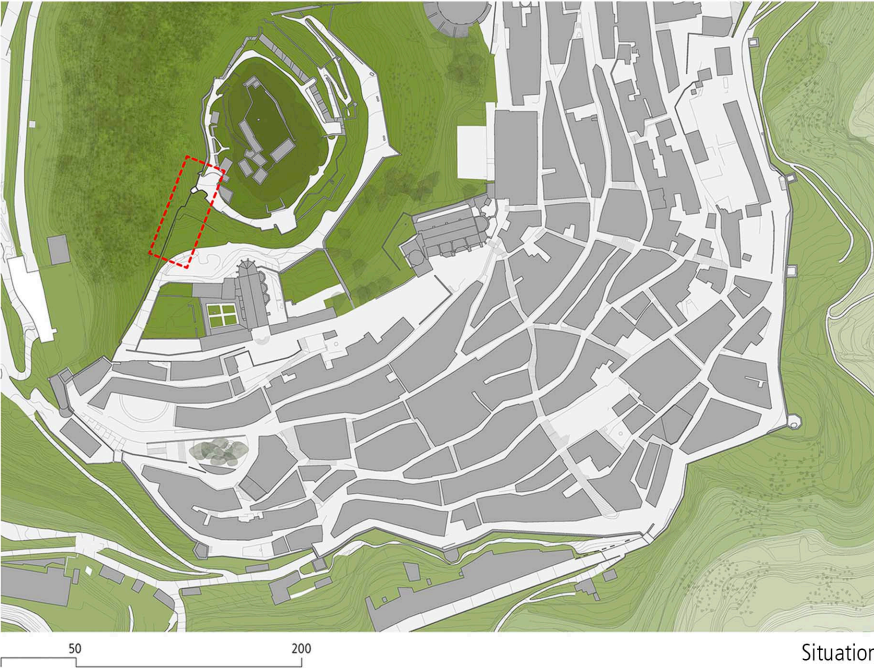
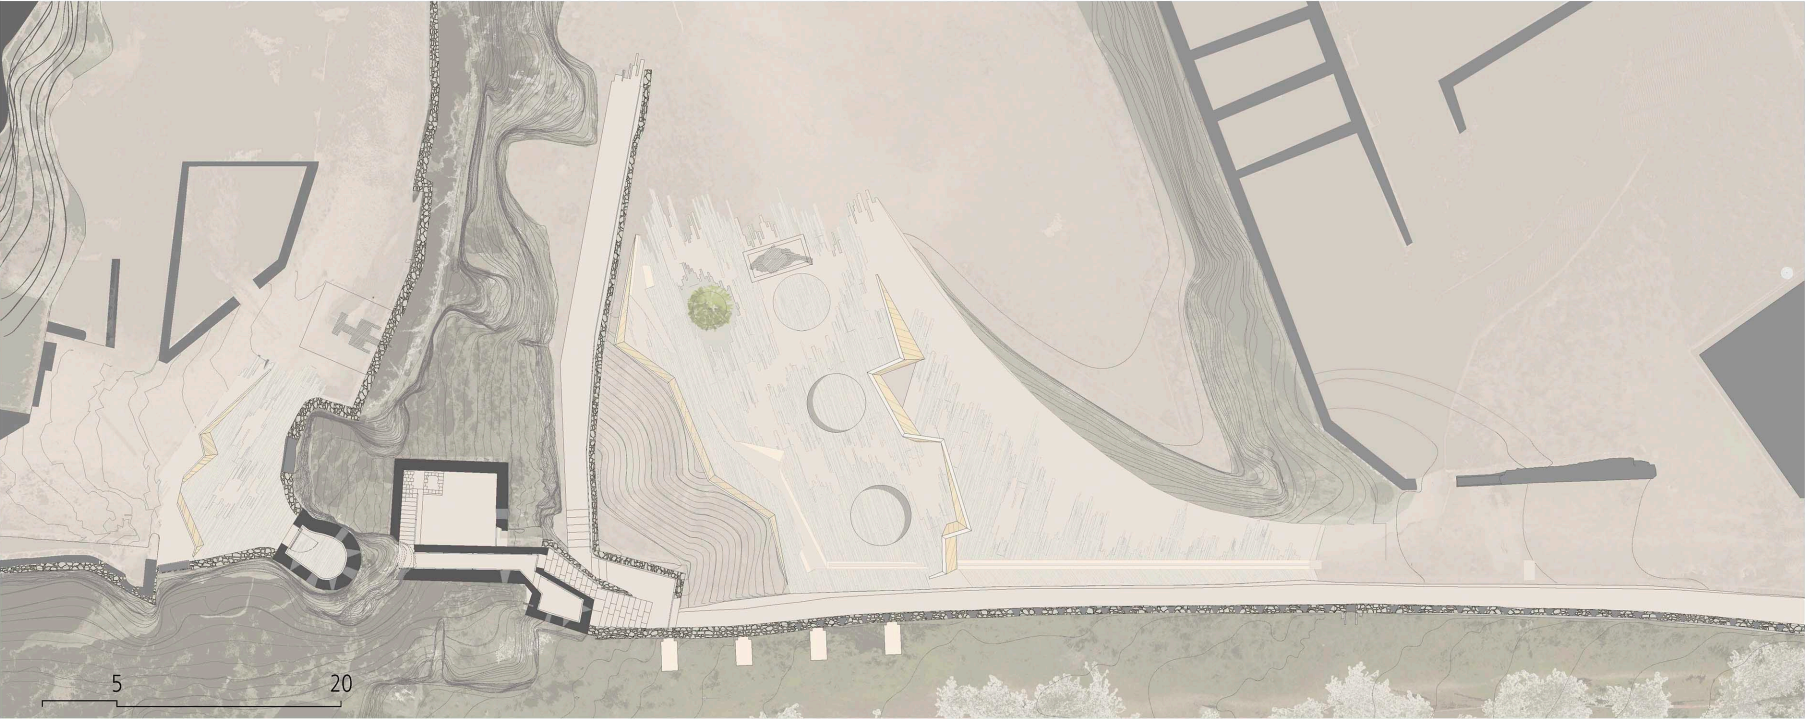
In the area of the loopholed wall, about 70 meters long and about 14 meters high, the main work has been focused on the structural consolidation, being at risk of collapse, as well as the cleaning and restoration. Outside the walls, four buttresses have been placed, reinforcing the foundation, recovering the exported land and sealing and consolidation of cracks.

In the interior of the walls, an important volume from Carlist War period fillings has been removed because of they affected structurally the wall, appearing numerous archaeological remains, deposited in the Museum of the Castle of Morella, as well as the finding of three lime ovens, leaving visible medieval rammed-earth that remained hidden.

For the collection of rainwater, the main cause of the pathologies caused in the masonry of the Castle, a system of diffuse pavements and pipes has been arranged that direct the waters to a pre-existing outdoor pool.

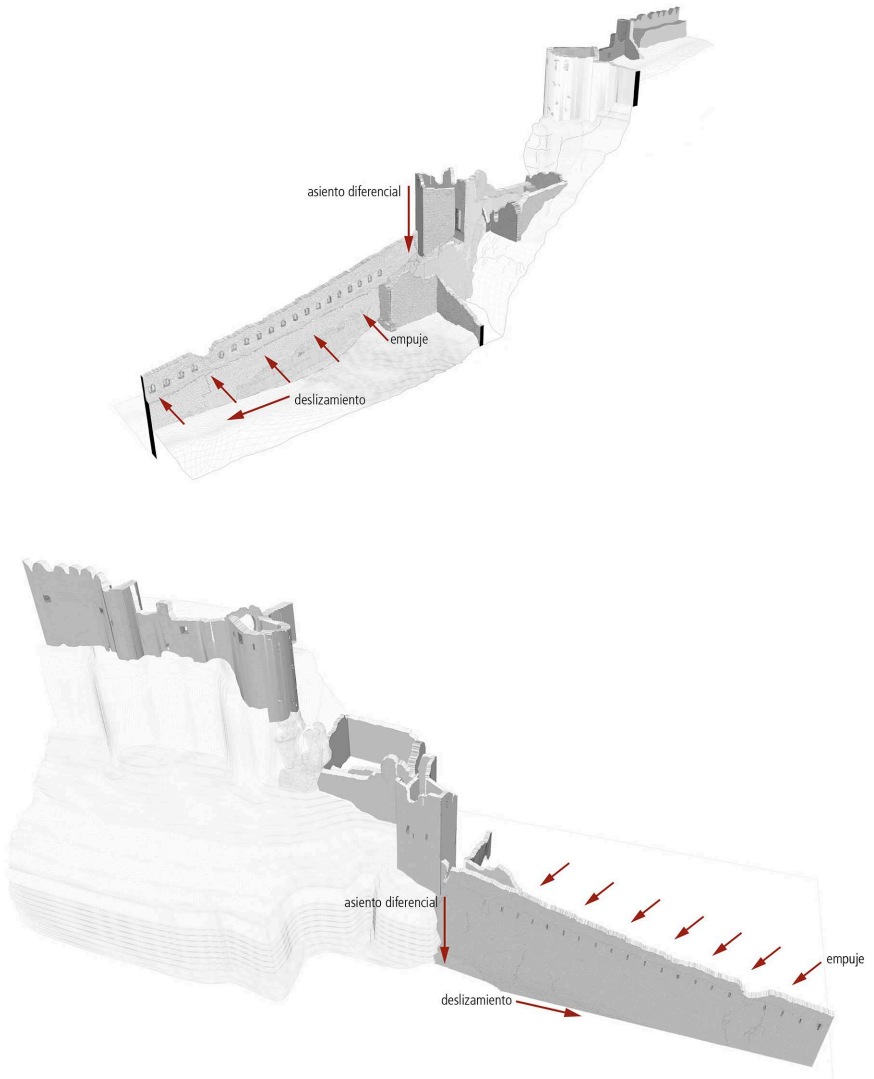
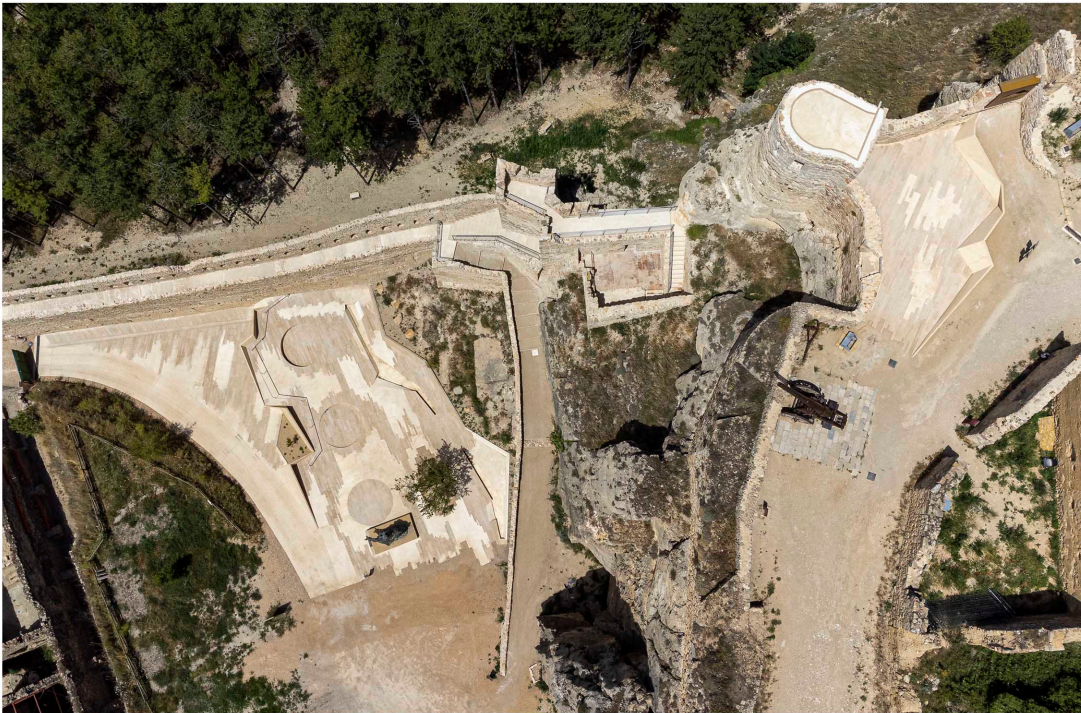
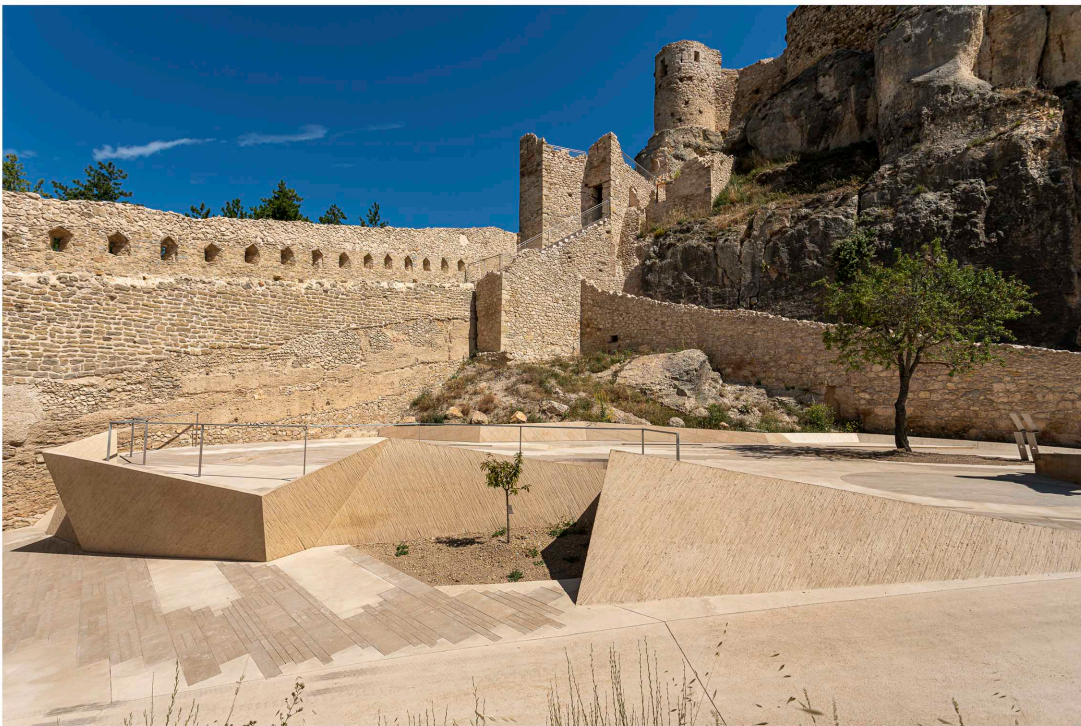
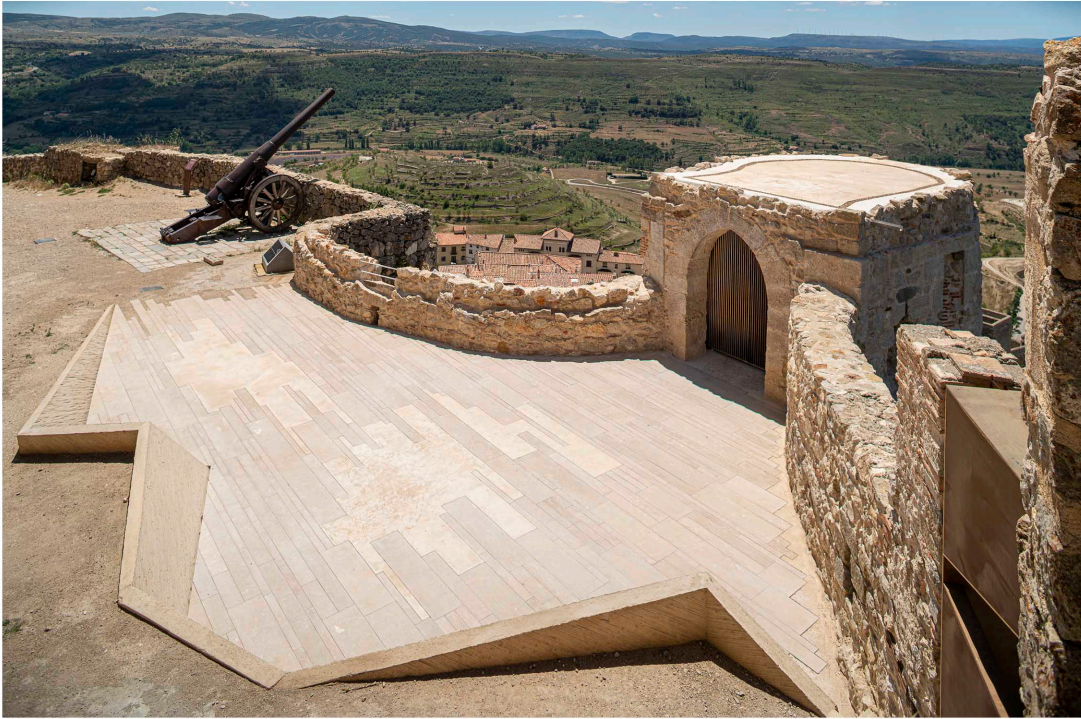
The access to the Sant Francesc Tower has been recovered by the execution of the roof in its wall-walks annex, its stairs, and the increase of the semi-demolished wall and the tense. All the masonry has been restored, including the ramp and its annex building.

In the area of Pardala Tower, the entire filling has been emptied to its original level to be able to waterproof and systematize the collection of water, executing his lost cover. The exterior masonry has been restored, with curious finds such as cannonballs embedded in the Tower, or a hidden gunboat.

In the same area, the ancient overhanging latrines, that remained undetected, have been enhancement, executing a carpentry that allows to emphasize and to leave visible the corbels of this important historical element, to be the point of entry in 1838 of the Carlist troops.
