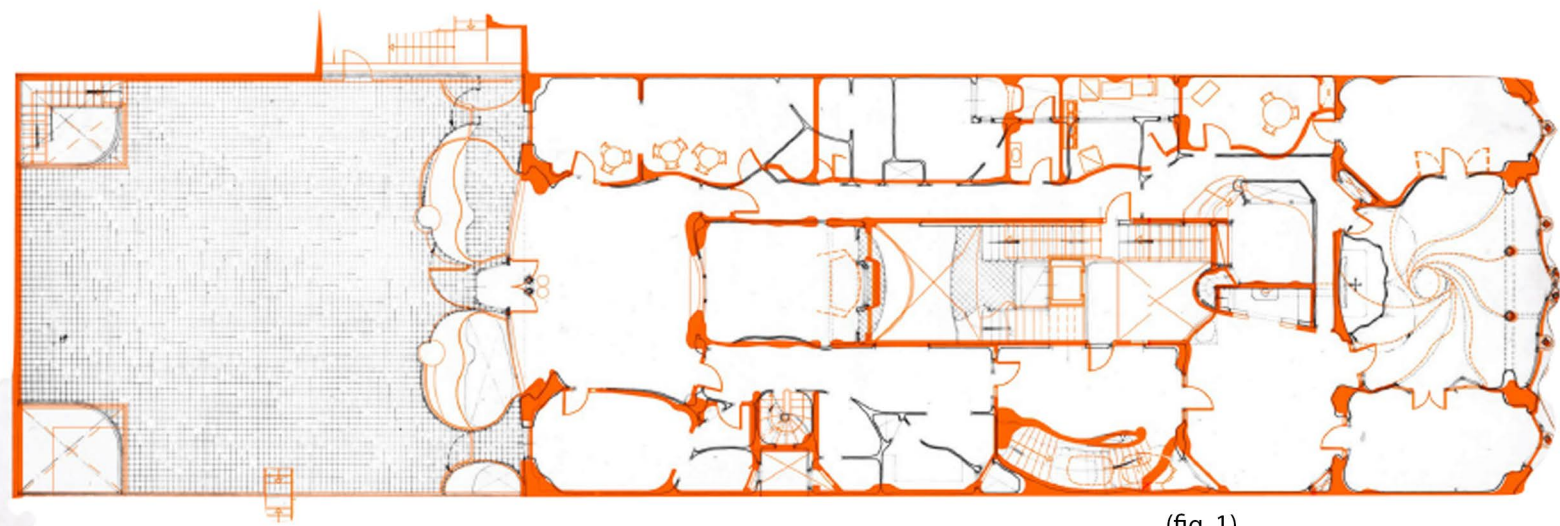
(fig. 1)

The superposition of the layout plans of the piano nobile from 2014 with the survey carried out in the early 1950s by the Friends of Gaudí, clearly indicates the alterations that have occurred in the floor belonging to the Batlló-Godó family (fig. 1). Similarly, historical images of the piano nobile as it was in 1927 show us partitions, doors, stuccoes and railings that in

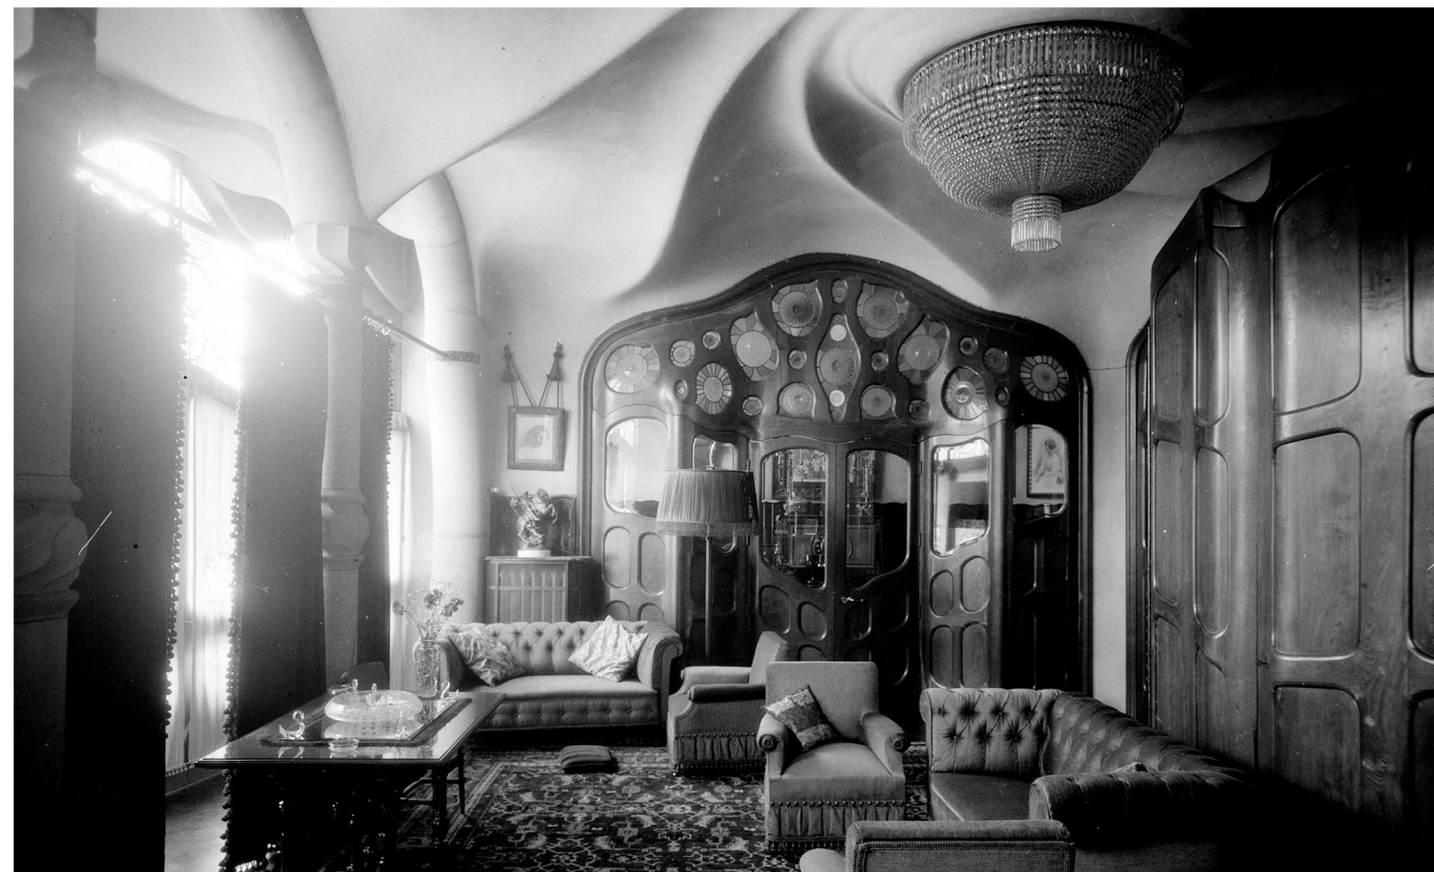
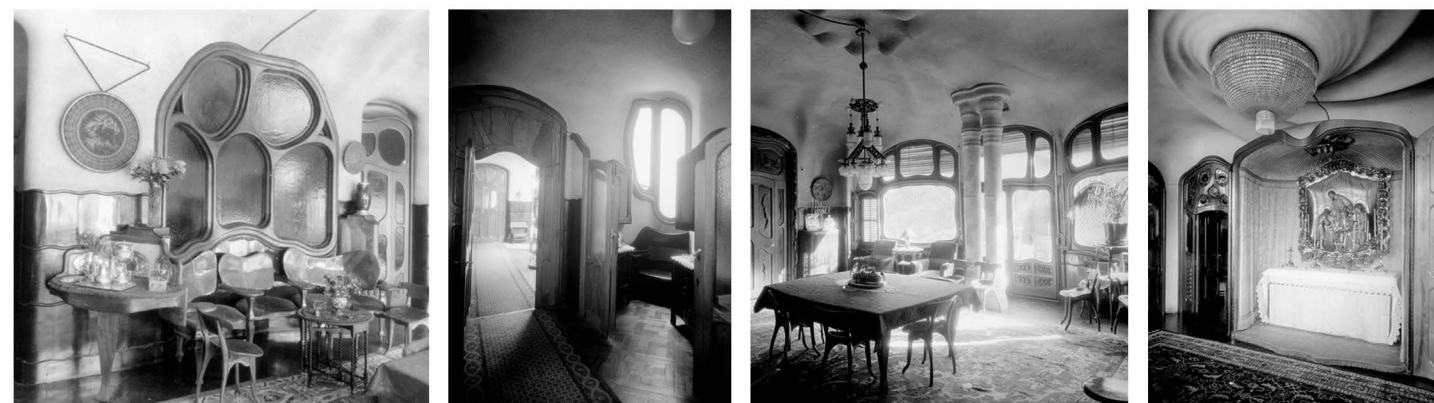
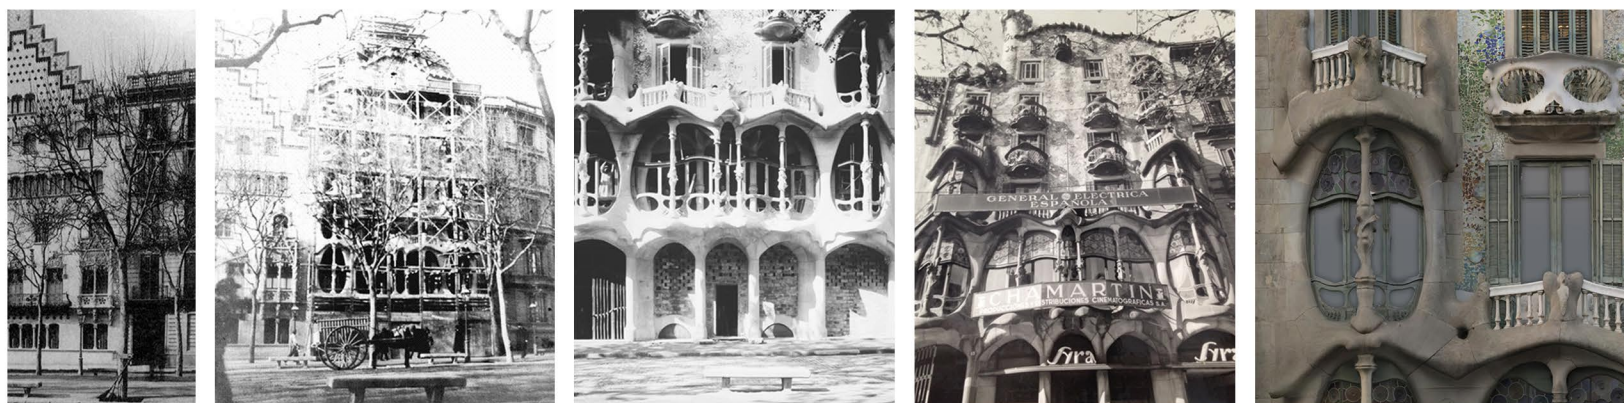
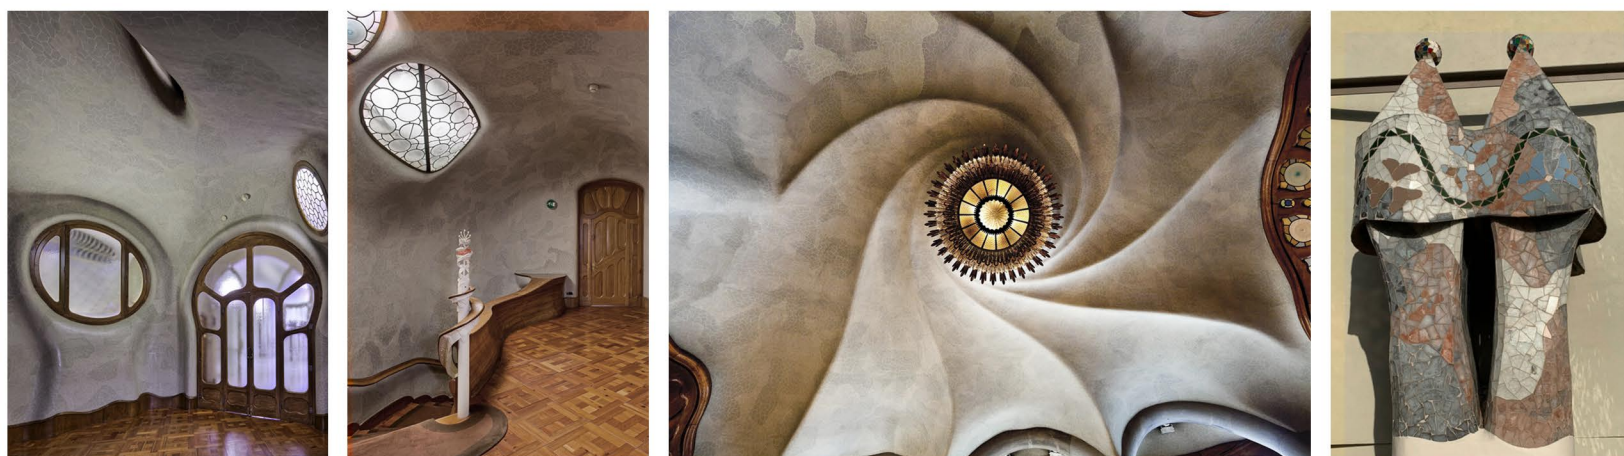
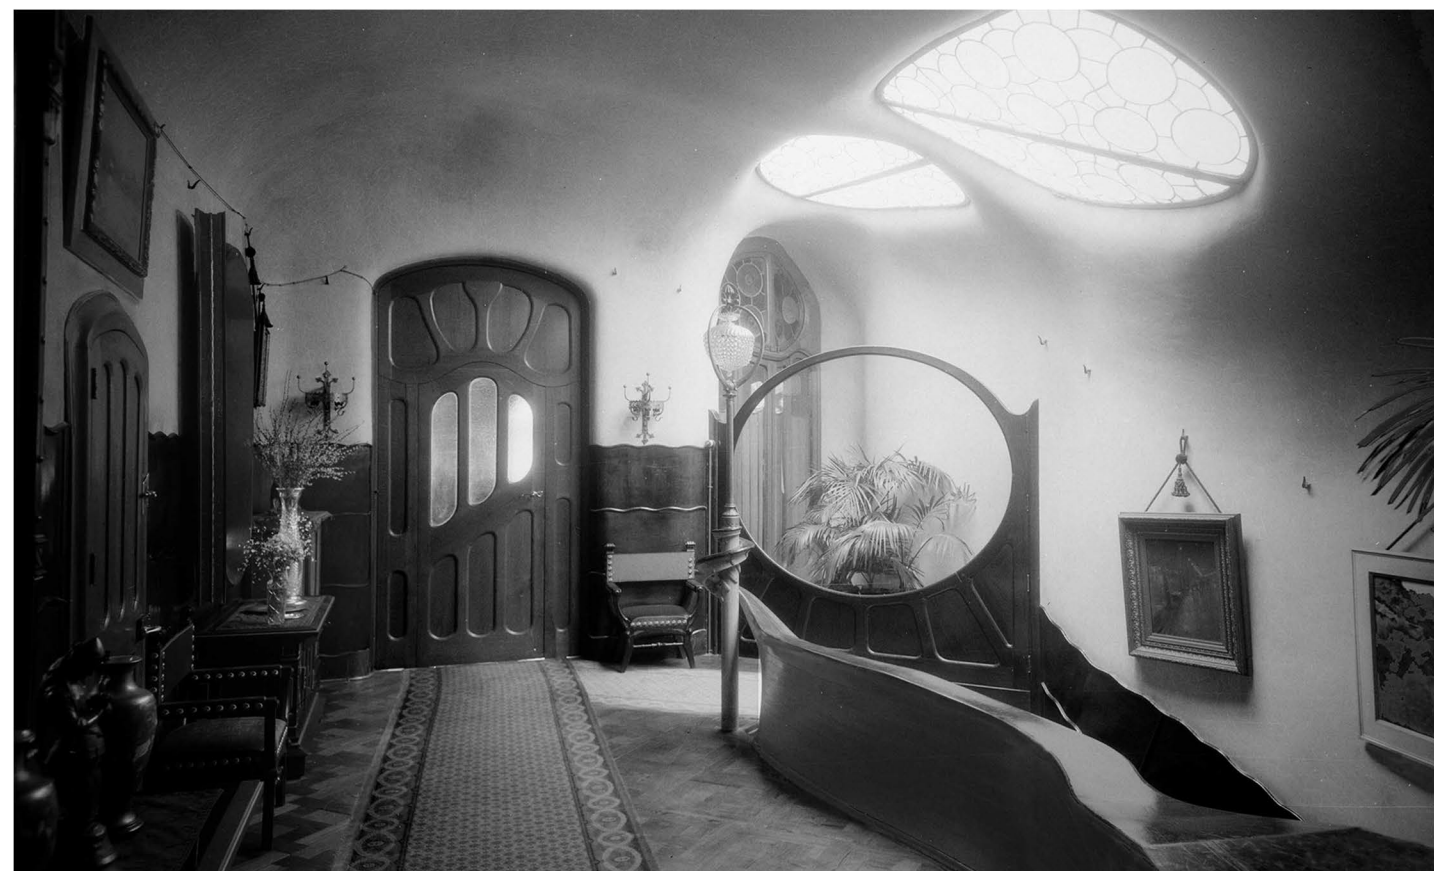
the period between 1955 and 1990 were altered and/or eliminated. (for example in National Museum of Art of Catalonia-MNAC, 104 wooden elements, between doors, shutters and closet doors attributed to Casa Batlló are conserved part of this collection on permanent exhibition)
