Excavados y recuperados sus recorridos quedaba el desafío de cerrar los huecos de las torres robadas, tanto por razones de seguridad como por devolver al edificio su sentido inicial en estos puntos. Aunque teníamos las piedras romanas que no se llevaron acumuladas en la parte baja del castillo y teníamos los rebajes en la peña del asiento de estos sillares, volver a colocarlos no tenía sentido: las piedras romanas ya eran un acopio constructivo del XVIII, de la misma forma que habían dejado de ser parte de las torres y parte de los edificios romanos para los que fueron labradas. La decisión de recuperar el cierre y emular las plataformas desaparecidas con madera tanalizada de pino Soria permitió evidenciar los cortes de la peña sin ocultarlos y usar un material que no competía con el complejo proceso estratigráfico del edificio.

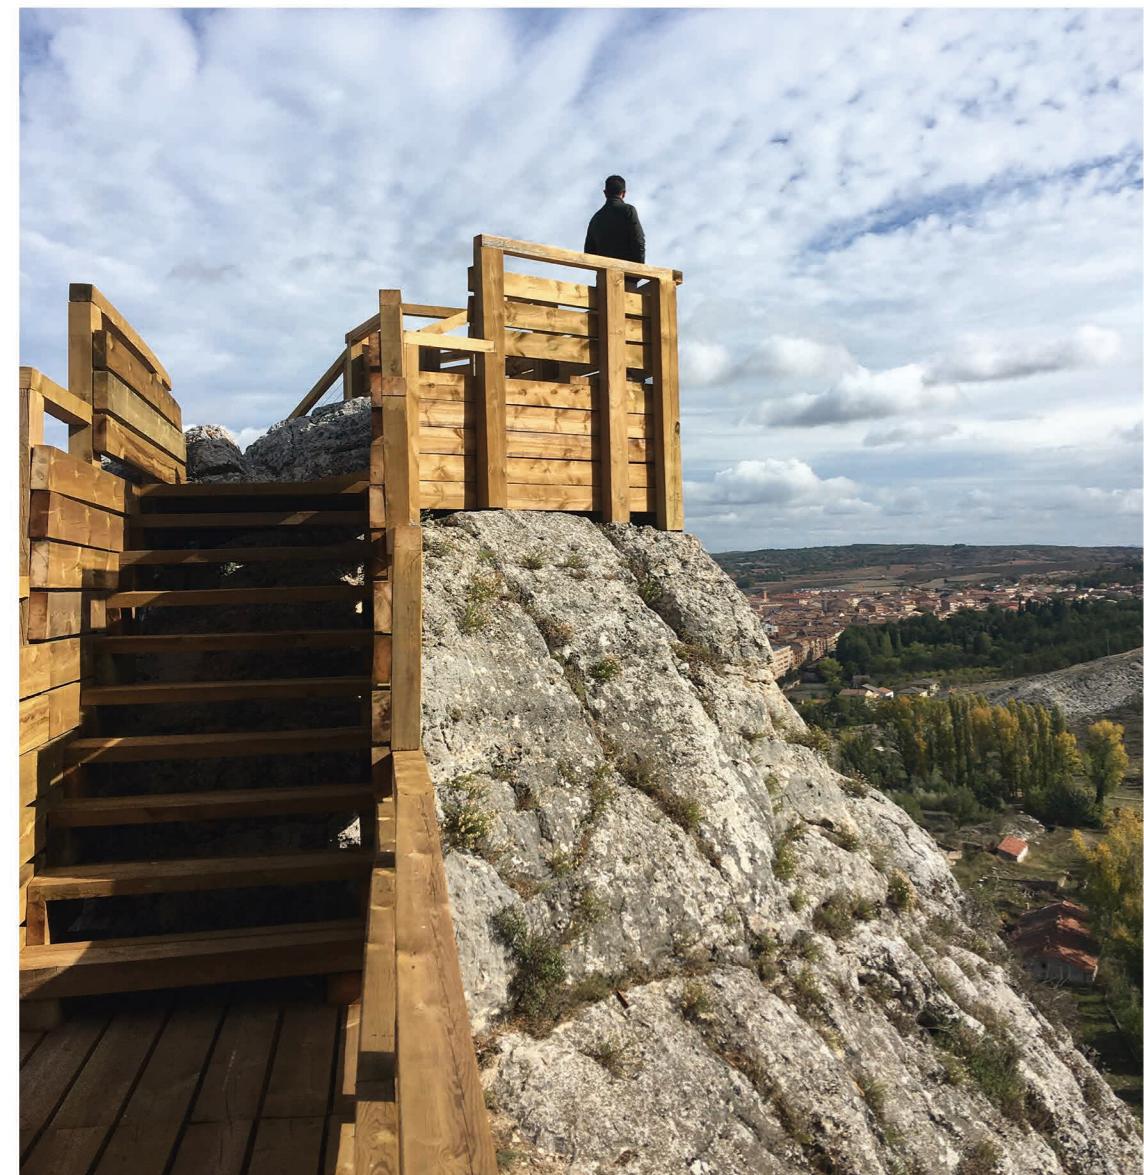
Peña alta de la torre después de la construcción de la estructura de madera que recrea las trazas de los muros

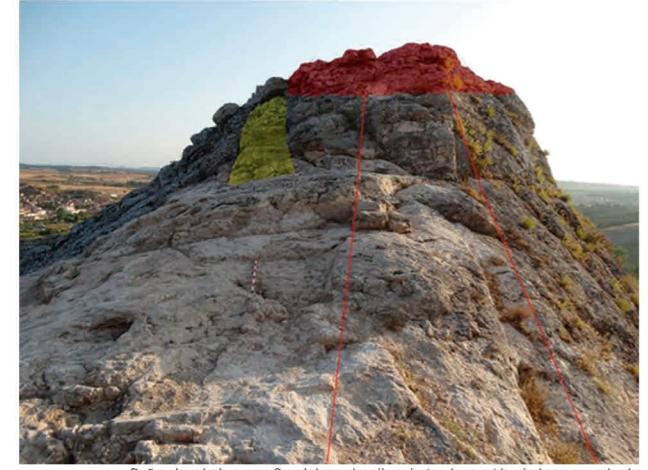
Peña alta de la torre Condal con huellas de implantación de la torre robada

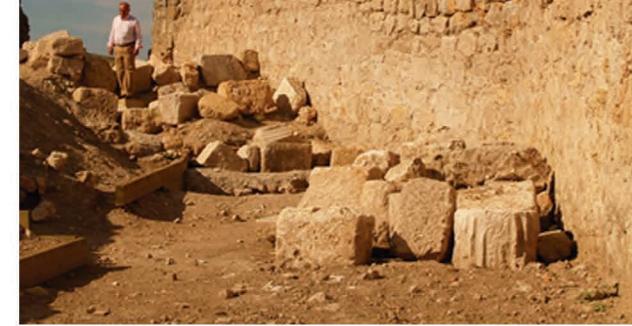
Acopio de piedras romanas desmontadas de las torres Condales

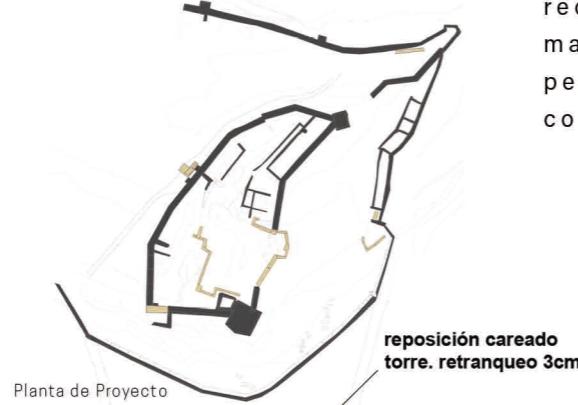
Planta de Proyecto

reposición careado
torre. retranqueo 3cm.

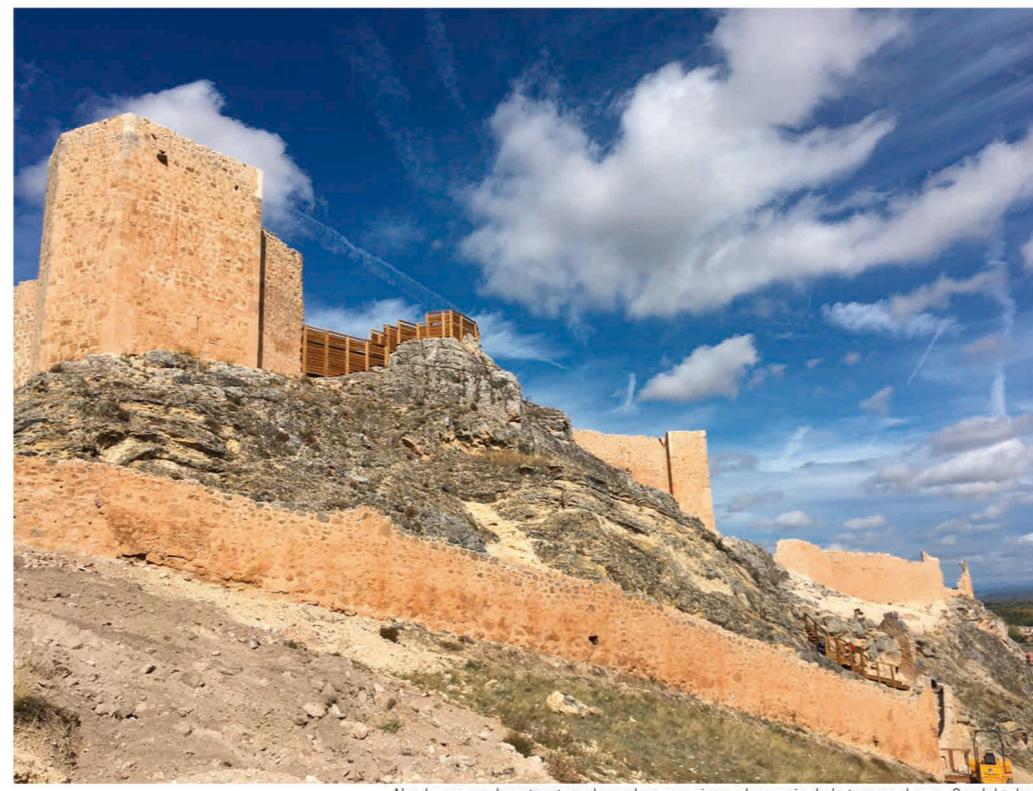
Alzado sur con la estructura de madera que cierra el espacio de la torre y el muro Condal robado

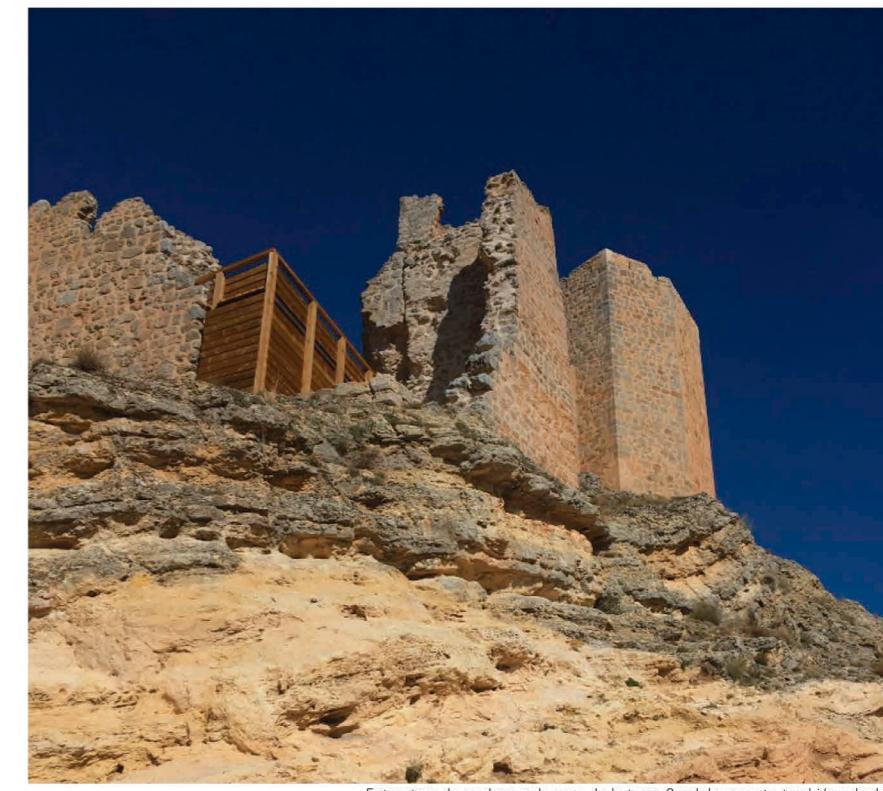
Estructura de madera en la zona de la torre Condal noroeste también robada
